Reality Capture (RECAP) project final report

30.1.2020

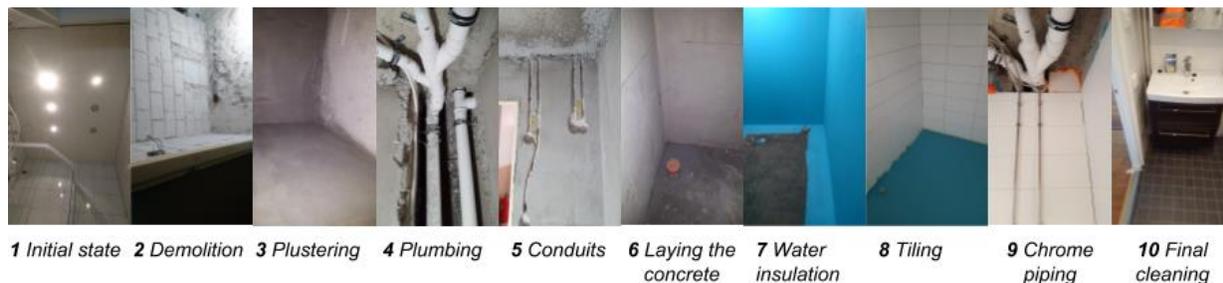
Fig.3. Example photos of 10 stages of bathroom innovation.

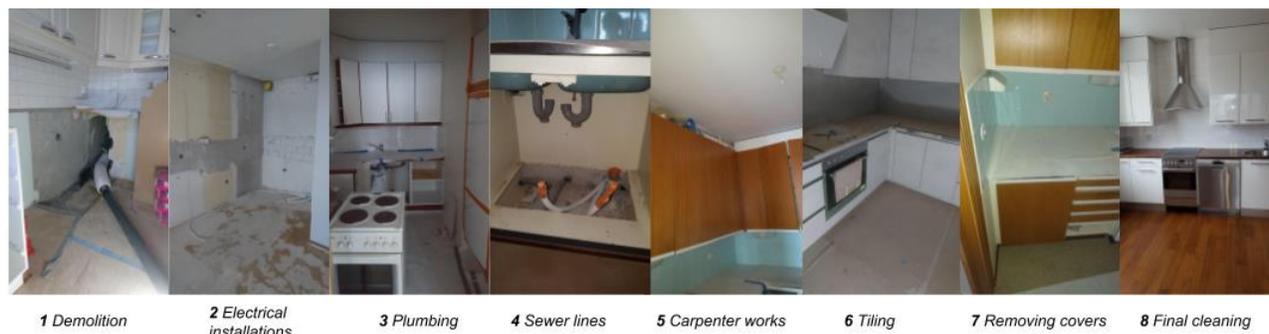
Fig.4. Example photos of 8 stages of kitchen innovation.

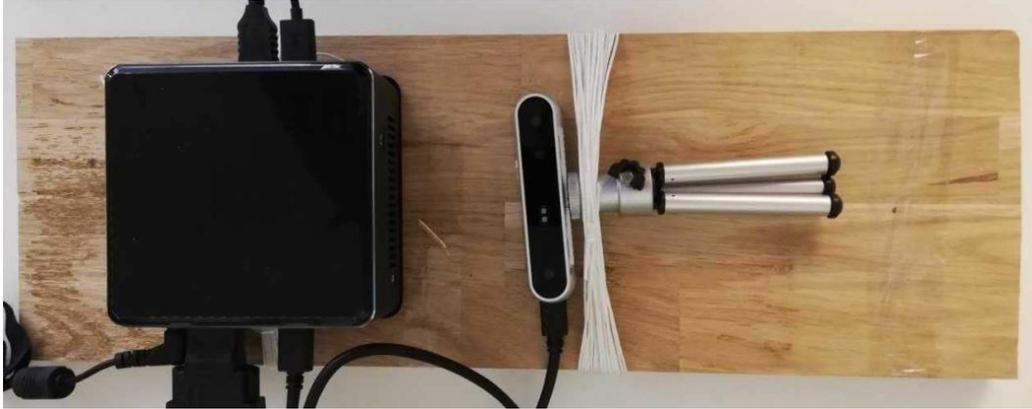
Figure 12: The mini-PC and camera installed in the factory

The camera system includes a mini PC for taking captured photos from camera and a depth camera for capturing photos in the factory (Figure 12). The camera was setup on a ceiling-mounted crane so that when the crane moved in the factory, the camera would be correctly positioned to take pictures of the element station (Figure 13).

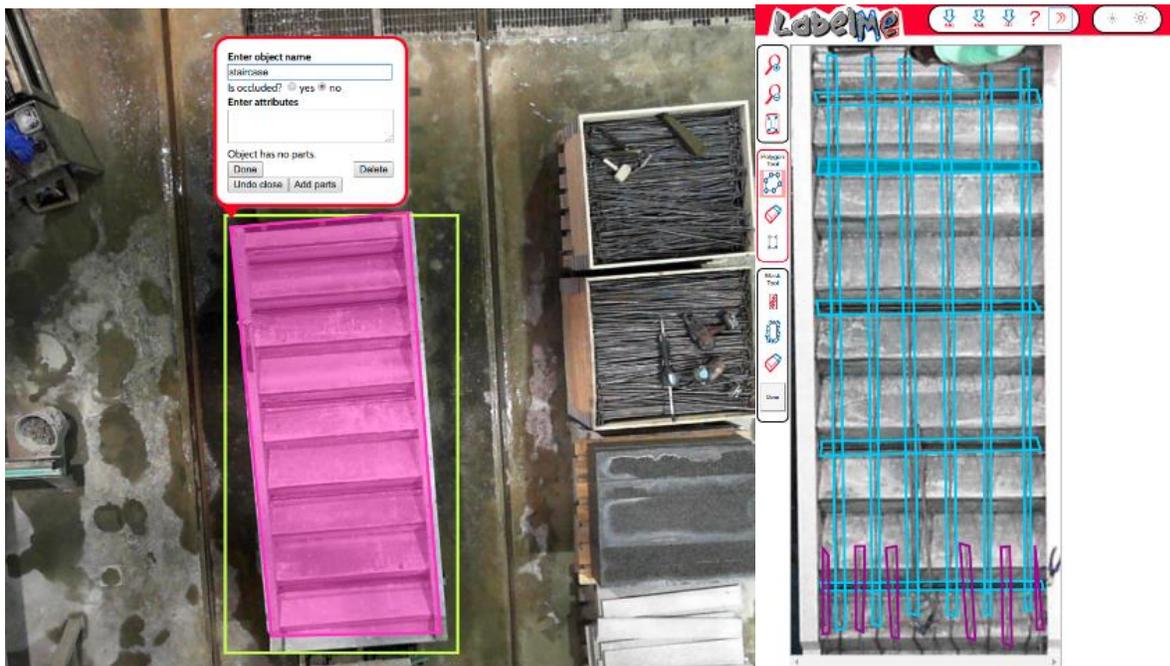
Figure 15. Manual labeling the data. The left image shows the way we labeled the staircase in the image. The right image shows the rebars labeling output.

We labeled manually 670 photos with a localized staircase and then labeled the rebars as illustrated in Figure 15. Three types of rebars, including A1-A2-MODIX , X5-Y7 and U3, are illustrated shown in Figure 16.
